# HP 310-1037 Hard Drive Replacement

Very straight forward repair with only a few common tools.

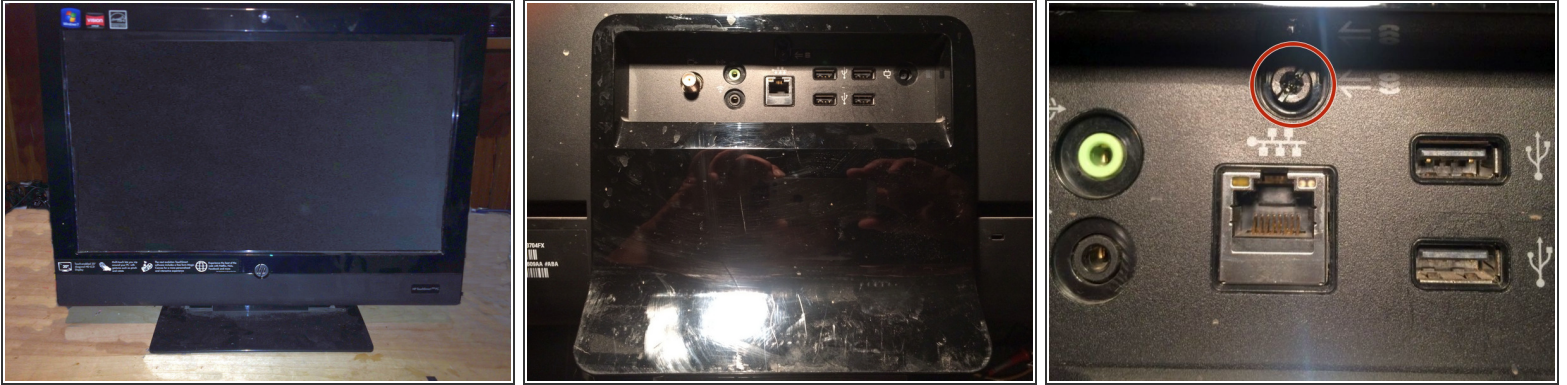
## Step 1 — Hard Drive

- HP310-1037 Touchsmart PC with a dead hard drive. The hard drive is located behind the stand cover.
- Lay the PC flat on the front to gain access to the stand cover
- Remove the single screw that holds the stand cover to the chassis with a flat tip screwdriver

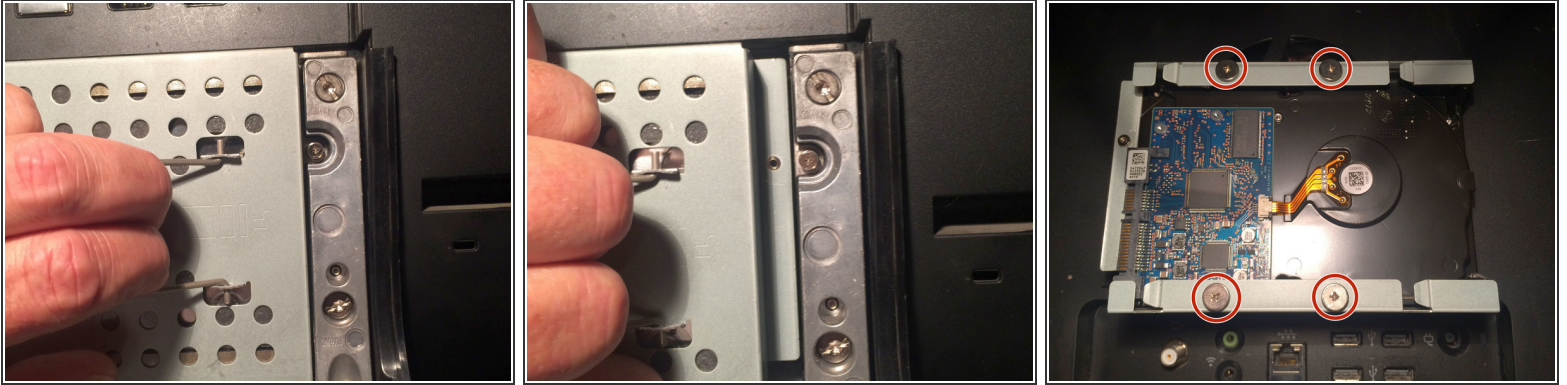
## Step 3

- Lift the handle on the hard drive caddy
- and pull it to the backside. This will remove the hard drive caddy from the computer.
- To remove the hard drive from the caddy, turn it over. There are four Phillips screws that hold the hard drive in place.
